# Evaluation of High-Slump Concrete For Bridge Deck Overlays Construction Report

Iowa Highway Research Board  
Project TR-427

September 2001  
Construction Report

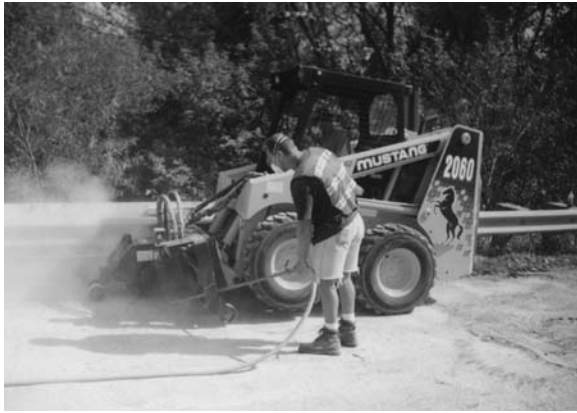
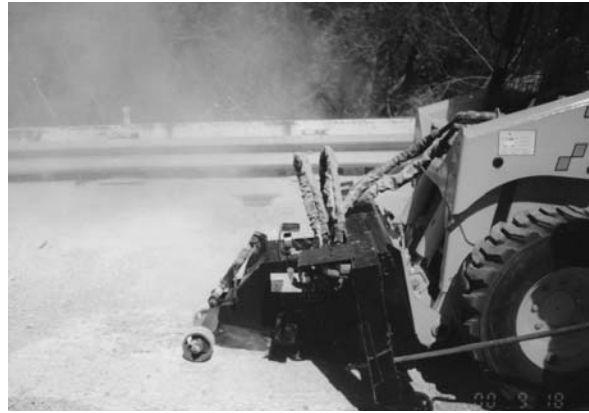
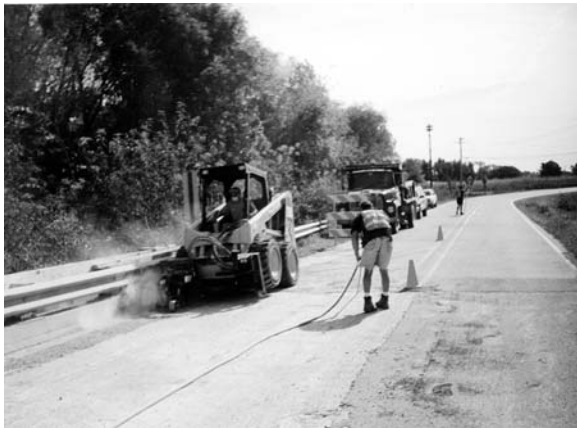
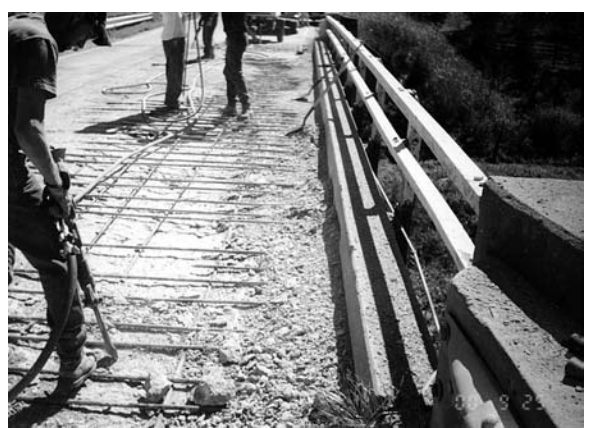
Use of milling, high-pressure air blast and jack hammers to remove deteriorated concrete from the bridge decks.

Construction began with the removal of deteriorated concrete from both bridge decks in mid September 2000. The contractor used a chain drag to locate deteriorated portions on each deck. Concrete removal was accomplished using a milling attachment on a skid loader, jack hammers and high pressure air blast.

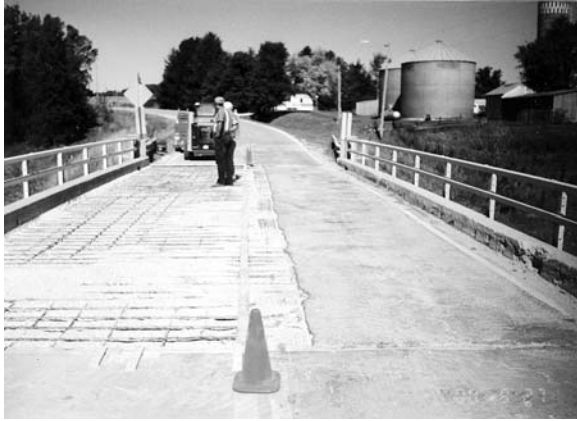
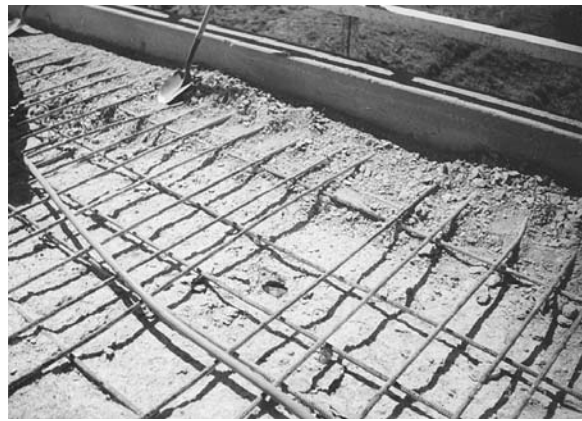
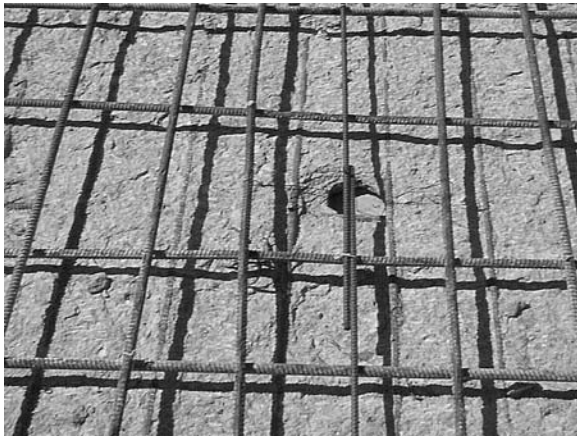
The Quasqueton bridge after removal of unsound concrete. Note that both top and bottom steel are visible in some areas and there is at least one hole clear through the deck.

The Quasqueton bridge had extensive PCC deterioration with most of the top steel and much of the bottom steel being exposed completely after concrete removal. However, the reinforcing steel itself was in good condition with very little corrosion. Because of the extensive concrete removal, only one lane was milled and overlaid at a time on this bridge. In contrast, the Independence bridge was in relatively good condition, allowing both lanes to be milled prior to deck placement.

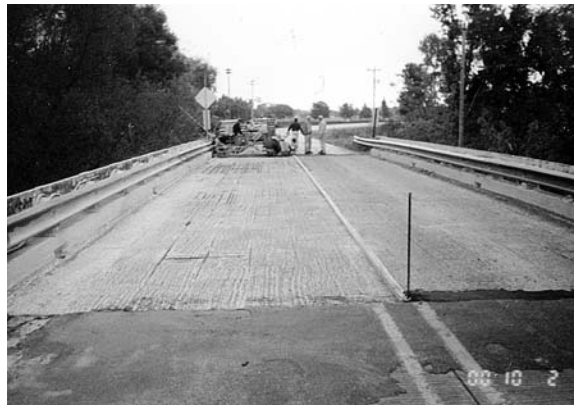
The Independence bridge after removal of unsound concrete from both lanes. Note that the majority of reinforcing steel remains covered with concrete.

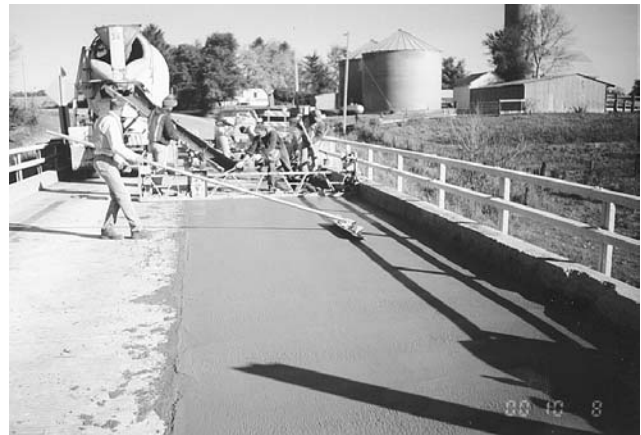
PCC placement on the Quasqueton bridge.

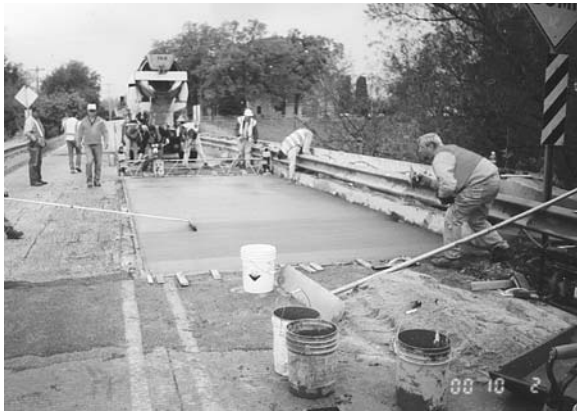
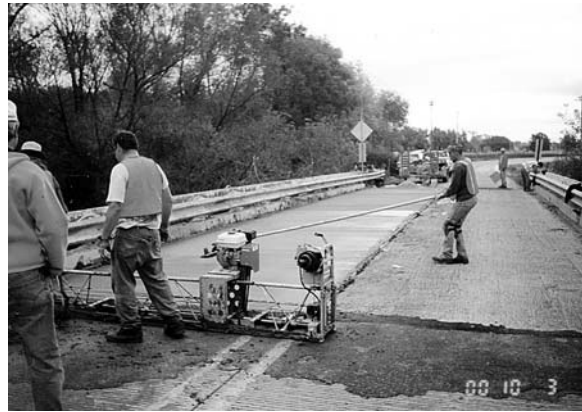
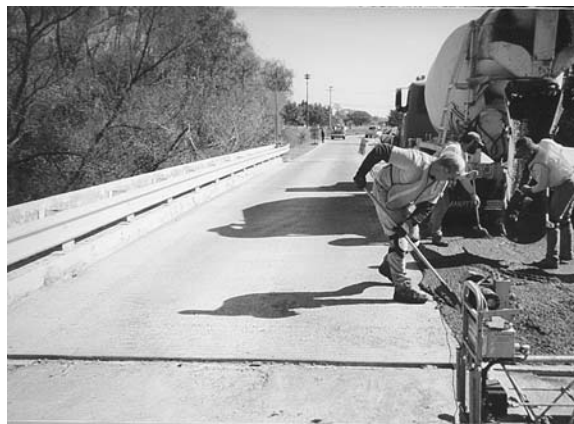
PCC Placement on the Independence bridge.

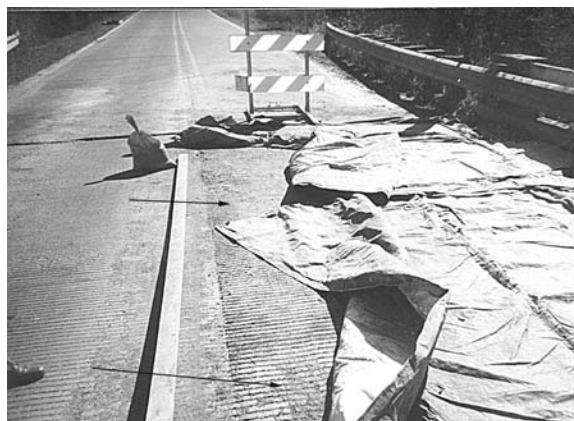
East-bound lane of the Independence bridge, showing the wheel track (arrowed) from a farm vehicle that passed over it approximately 40 minutes after PCC placement.

After the final pour on the east-bound lane of the Independence bridge, the concrete was covered with tarp for curing and barricades were placed on the lane. This left the bridge open for one lane of traffic. Approximately 40 minutes later, a motorist moved the barricades and drove across the bridge with a wide farm vehicle. This caused a minor wheel track indentation in the concrete of the east-bound lane near the centerline of the bridge (see photograph in Appendix B).
